RED-ACT Report

Real-time Earthquake Damage Assessment using City-scale Time-history analysis

Jun. 22, M5.4 Gongxian County, Sichuan Province Earthquake

Research group of Xinzheng Lu at Tsinghua University (luxz@tsinghua.edu.cn)

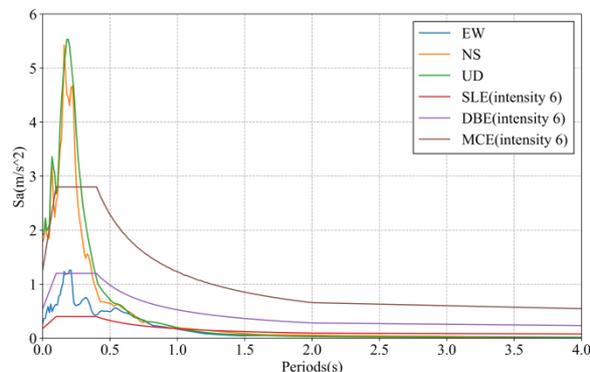
Figure 1 Response spectra of the recorded ground motions with maximal PGA

10 ground motions near to epicenter of this earthquake were analyzed. The names and locations of the stations can be found Table 1. The maximal recorded peak ground acceleration (PGA) is **190** cm/s/s. The corresponding response spectra in comparison with the design spectra specified in the Chinese Code for Seismic Design of Buildings are shown in Figure 1.

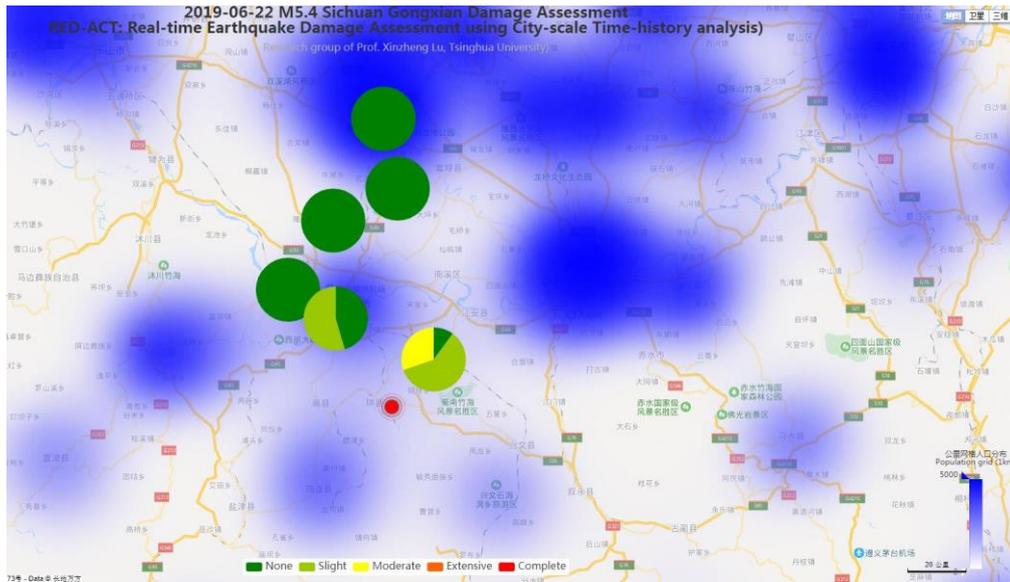
Figure 2 Damage ratio distribution of the buildings near to different stations

Using the real-time ground motions obtained from the strong motion networks and the **city-scale nonlinear time-history analysis (see the Appendix of this report)**, the damage ratios of buildings located in different places can be obtained. The building damage distribution and the human uncomfortableness distribution near to different stations is shown in Figure 2 and Figure 3, respectively. These outcomes can provide a reference for post-earthquake rescue work.

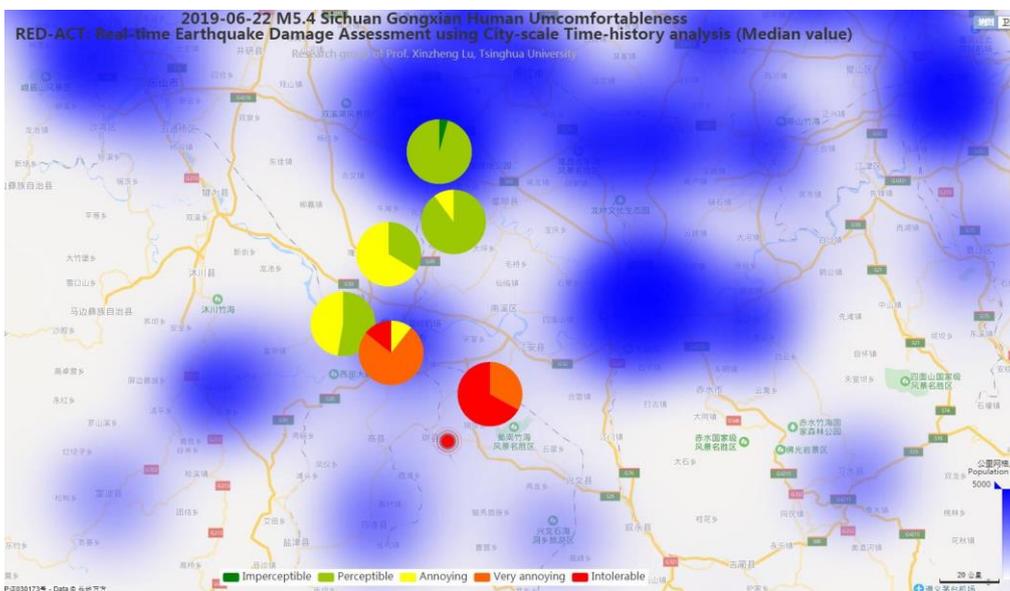
Figure 3 Human uncomfatableness distribution near to different stations

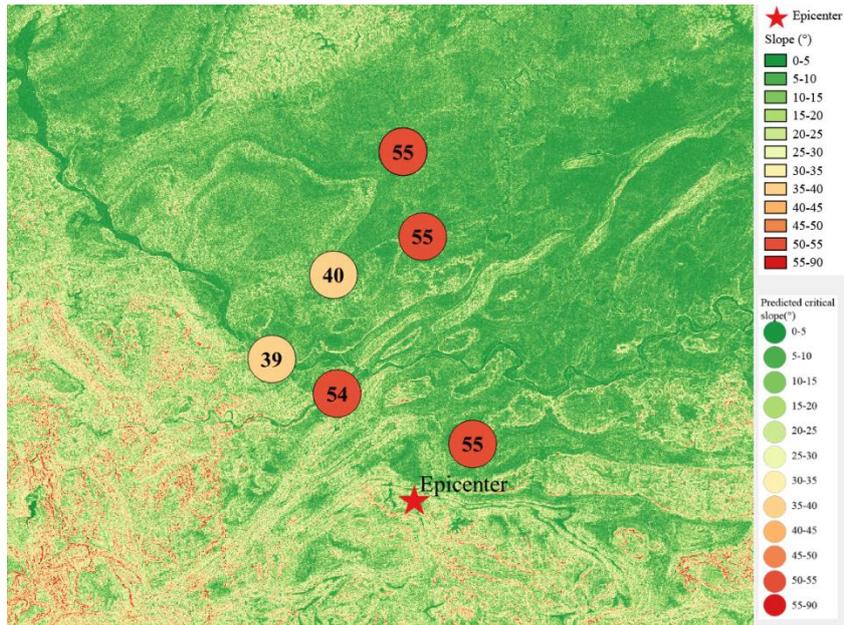
(a) The proportion of the landslide slab thickness that is saturated equals 0%

According to local topographic data, lithology data and ground motion records, the distribution of earthquake-induced landslide near to different stations under the different proportions of the landslide slab thickness that is saturated can be calculated, as shown in Figure 4. The basemap shows the distribution of the local slope. The number in the circle represents the critical slope of the landslide. The earthquake-induced landslide tends to occur with a higher probability when the slope is larger than this threshold value.

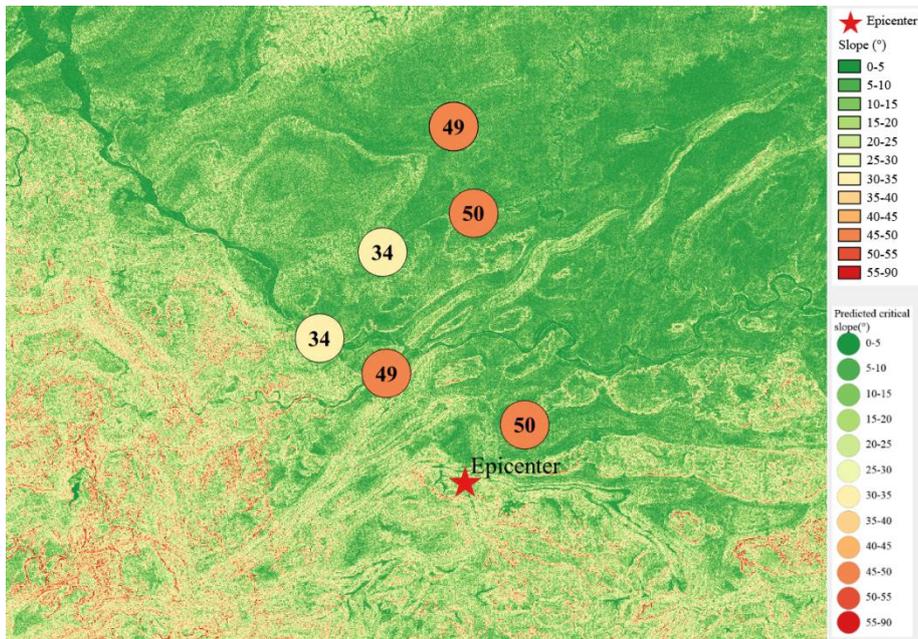
(b) The proportion of the landslide slab thickness that is saturated equals 50%

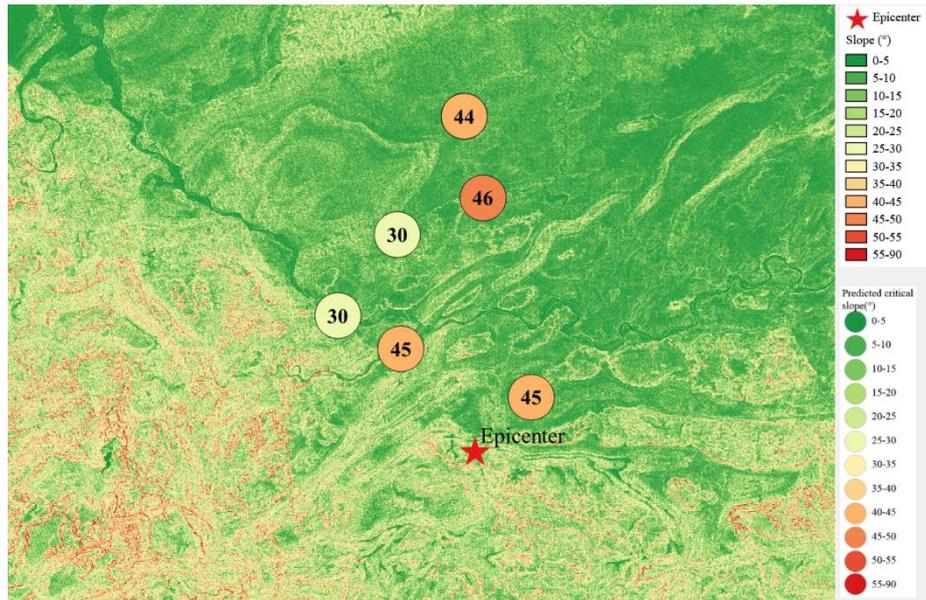
(c) The proportion of the landslide slab thickness that is saturated equals 90%
 Figure 4 Distribution of earthquake-induced landslide near to different stations
