RED-ACT Report

Real-time Earthquake Damage Assessment using City-scale Time-history analysis

Jul. 04, M5.6 Gongxian County, Sichuan Province Earthquake

Research group of Xinzheng Lu at Tsinghua University (luxz@tsinghua.edu.cn)

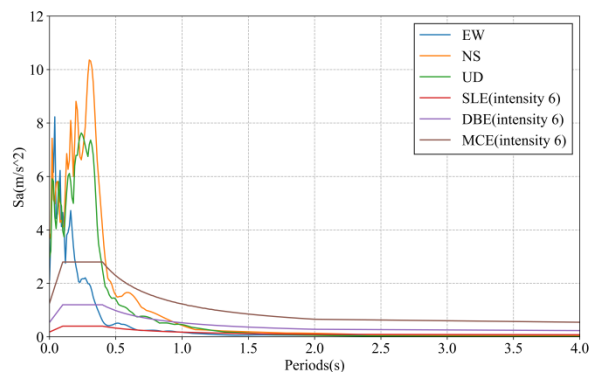
Figure 1 Response spectra of the recorded ground motions with maximal PGA

23 ground motions near to epicenter of this earthquake were analyzed. The names and locations of the stations can be found Table 1. The maximal recorded peak ground acceleration (PGA) is **368** cm/s/s. The corresponding response spectra in comparison with the design spectra specified in the Chinese Code for Seismic Design of Buildings are shown in Figure 1.

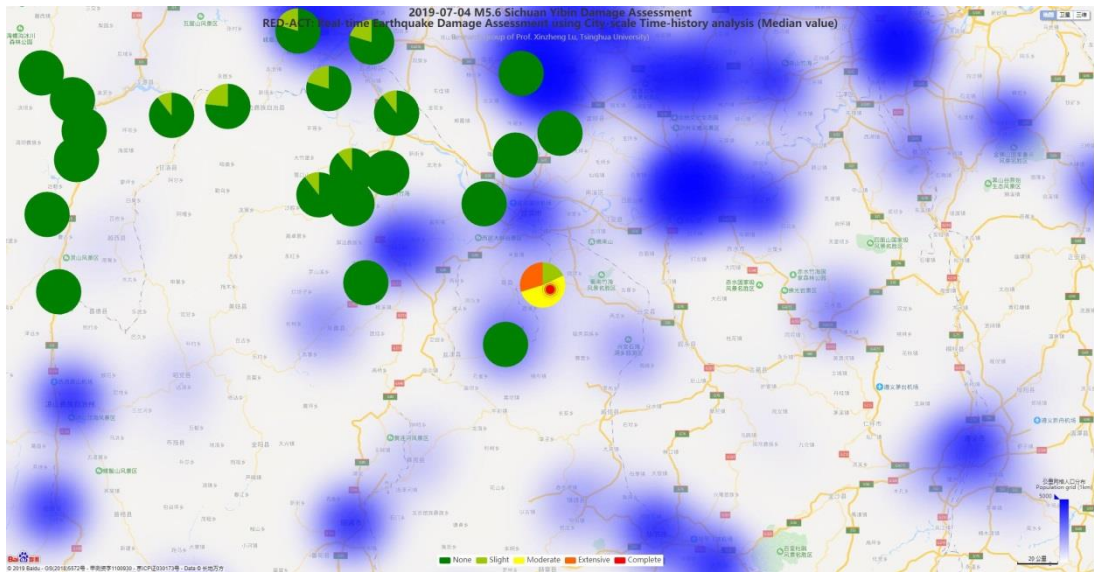
Figure 2 Damage ratio distribution of the buildings near to different stations

Using the real-time ground motions obtained from the strong motion networks and the **city-scale nonlinear time-history analysis (see the Appendix of this report)**, the damage ratios of buildings located in different places can be obtained. The building damage distribution and the human uncomfotableness distribution near to different stations is shown in Figure 2 and Figure 3, respectively. These outcomes can provide a reference for post-earthquake rescue work.

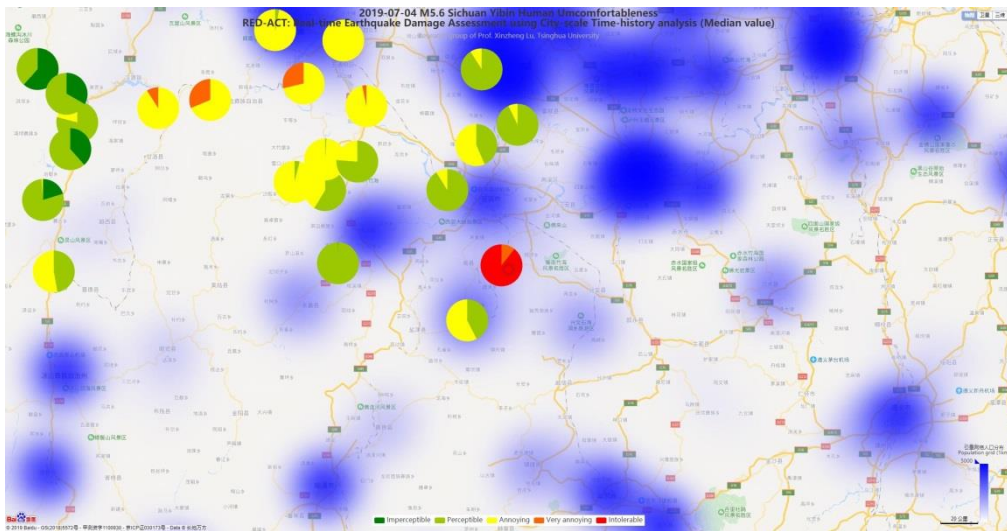
Figure 3 Human uncomfortableness distribution near to different stations

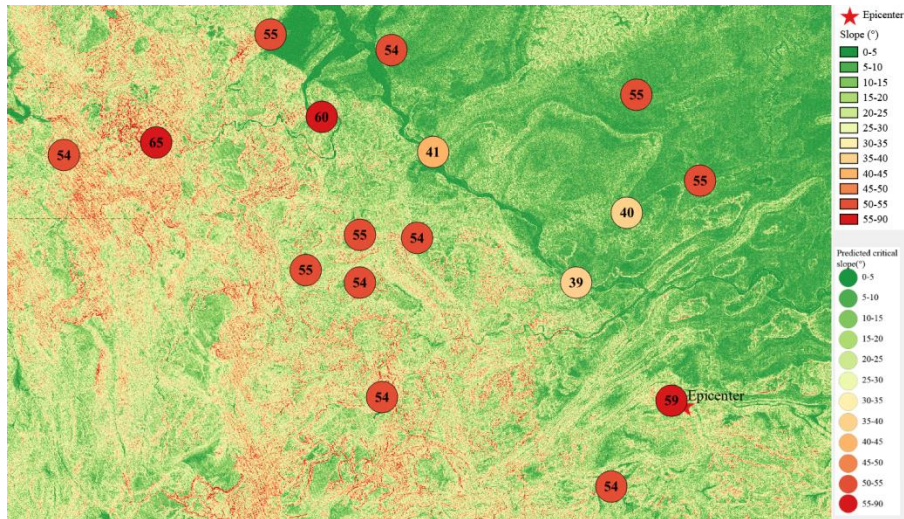
(a) The proportion of the landslide slab thickness that is saturated equals 0%

Figure 4 Distribution of earthquake-induced landslide near to different stations

According to local topographic data, lithology data and ground motion records, the distribution of earthquake-induced landslide near to different stations under the different proportions of the landslide slab thickness that is saturated can be calculated, as shown in Figure 4. The basemap shows the distribution of the local slope. The number in the circle represents the critical slope of the landslide. The earthquake-induced landslide tends to occur with a higher probability when the slope is larger than this threshold value.

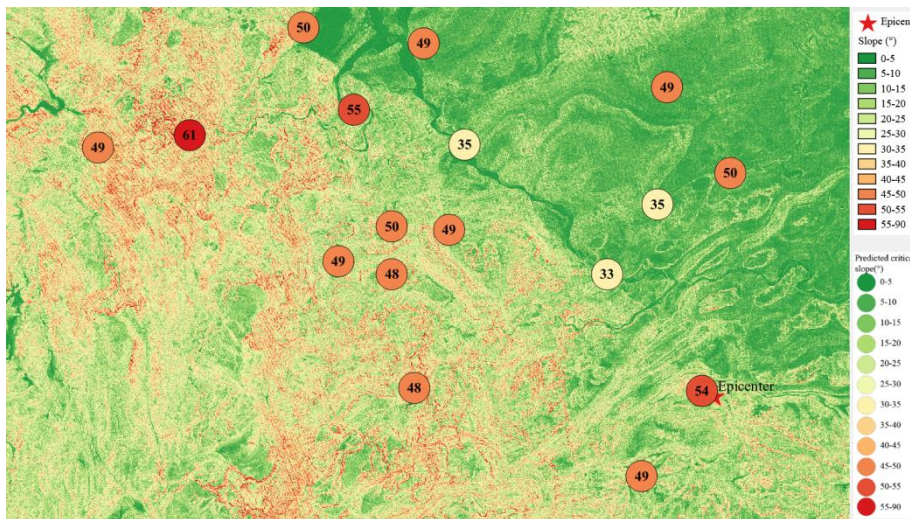
(b) The proportion of the landslide slab thickness that is saturated equals 50%

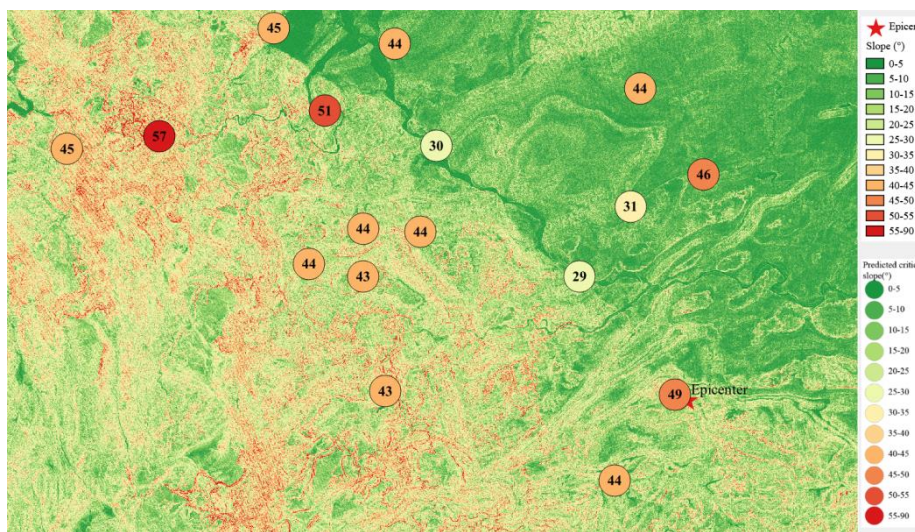
(c) The proportion of the landslide slab thickness that is saturated equals 90%
