## RED-ACT Report

### Real-time Earthquake Damage Assessment using City-scale Time-history analysis

### Feb. 13, M7.1 Fukushima-ken Oki, Japan Earthquake

Research group of Xinzheng Lu at Tsinghua University (luxz@tsinghua.edu.cn)

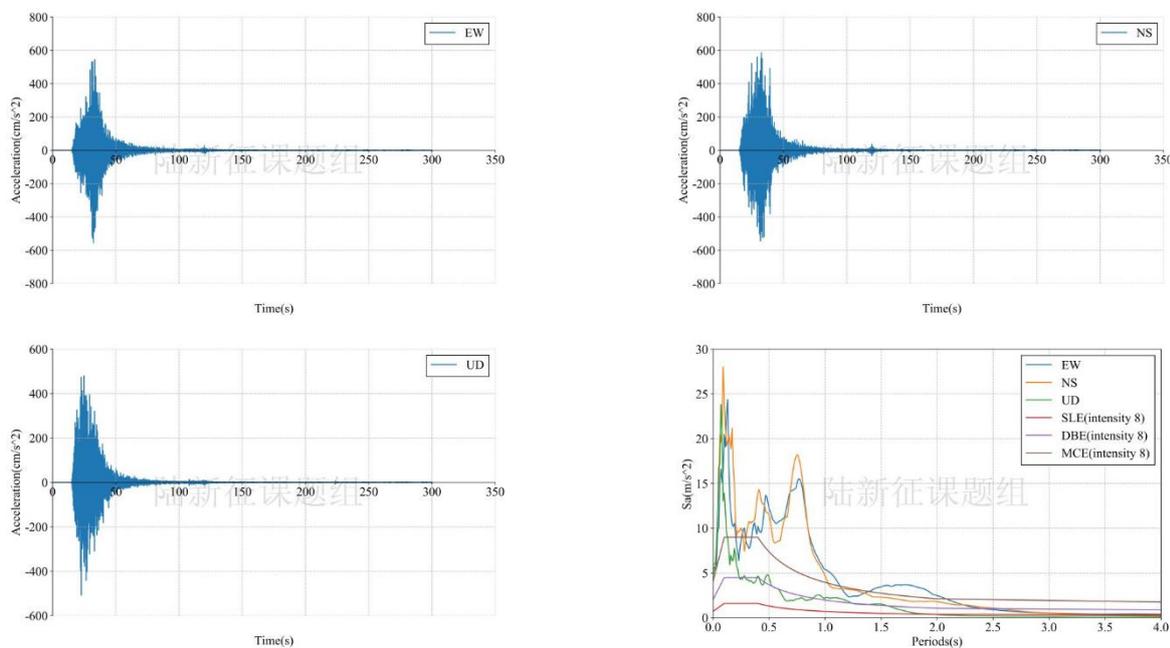
Figure 1 Waveform and response spectra of the recorded ground motions with maximal PGA

**27** ground motions near to epicenter of this earthquake were analyzed. The names and locations of the stations can be found Table 1. The maximal recorded peak ground acceleration (PGA) is **586.1** cm/s/s. The waveform and corresponding response spectra in comparison with the design spectra specified in the Chinese Code for Seismic Design of Buildings are shown in Figure 1.

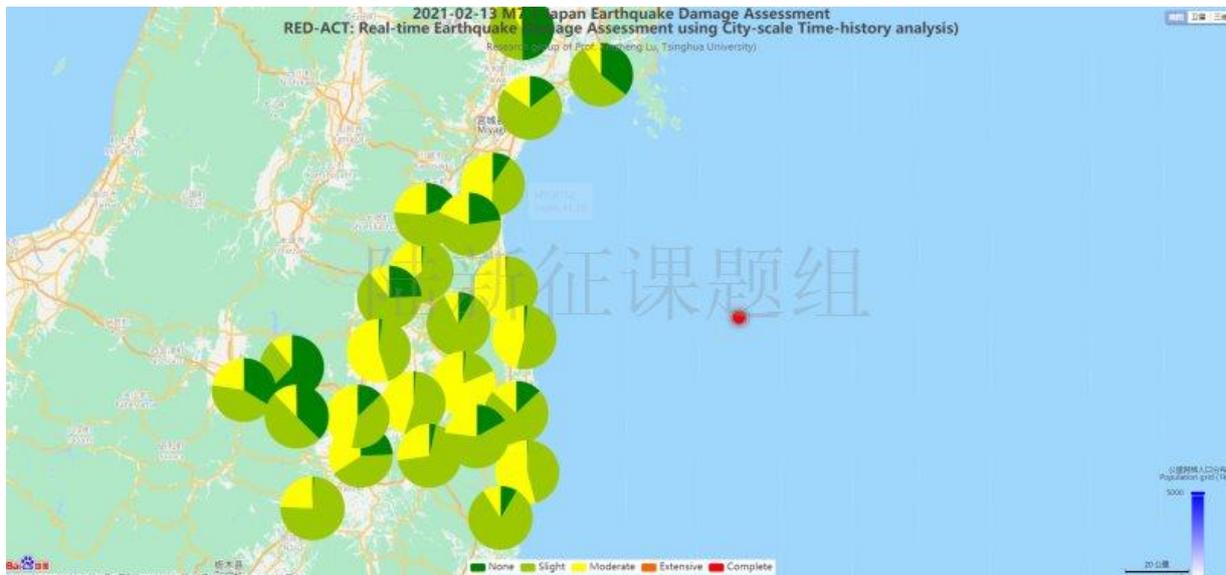
Figure 2 Damage ratio distribution of the buildings near to different stations

Using the real-time ground motions obtained from the strong motion networks and the **city-scale nonlinear time-history analysis**, the damage ratios of buildings located in different places can be obtained. The building damage distribution and the human feeling distribution near to different stations are shown in Figure 2 and Figure 3, respectively. These outcomes can provide a reference for post-earthquake rescue work. Note that during the 2011 Tohoku earthquake, the buildings in the Fukushima region have already experienced strong shaking. Consequently, the seismic resistance of the buildings should be stronger than the average level.

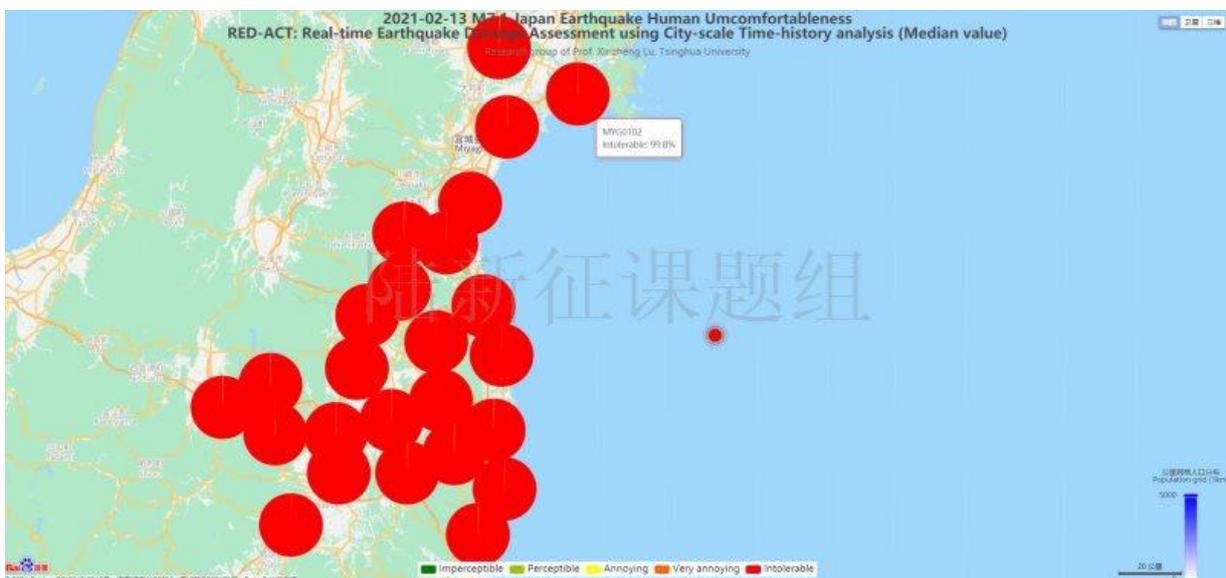
Figure 3 Human feeling distribution near to different stations

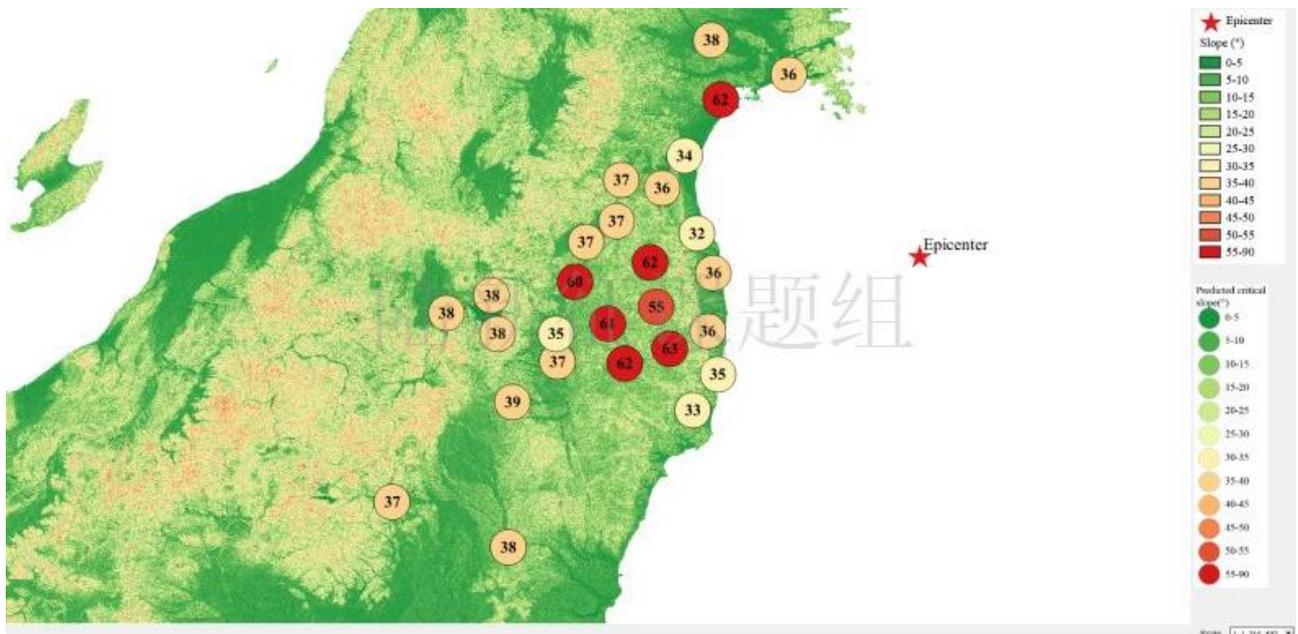
(a) The proportion of the landslide slab thickness that is saturated equals 0%

According to local topographic data, lithology data and ground motion records, the distribution of earthquake-induced landslide near to different stations under the different proportions of the landslide slab thickness that is saturated can be calculated, as shown in Figure 4. The basemap shows the distribution of the local

slope. The number in the circle represents the critical slope of the landslide. The earthquake-induced landslide tends to occur with a higher probability when the slope is larger than this threshold value.

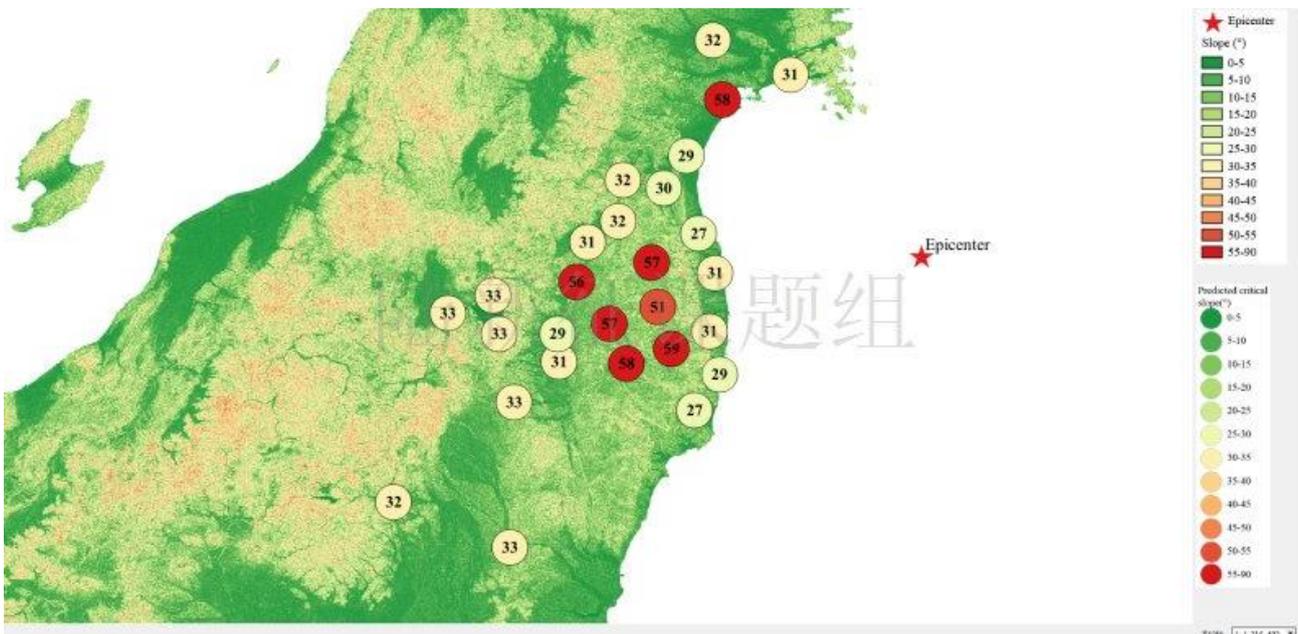
(b) The proportion of the landslide slab thickness that is saturated equals 50%

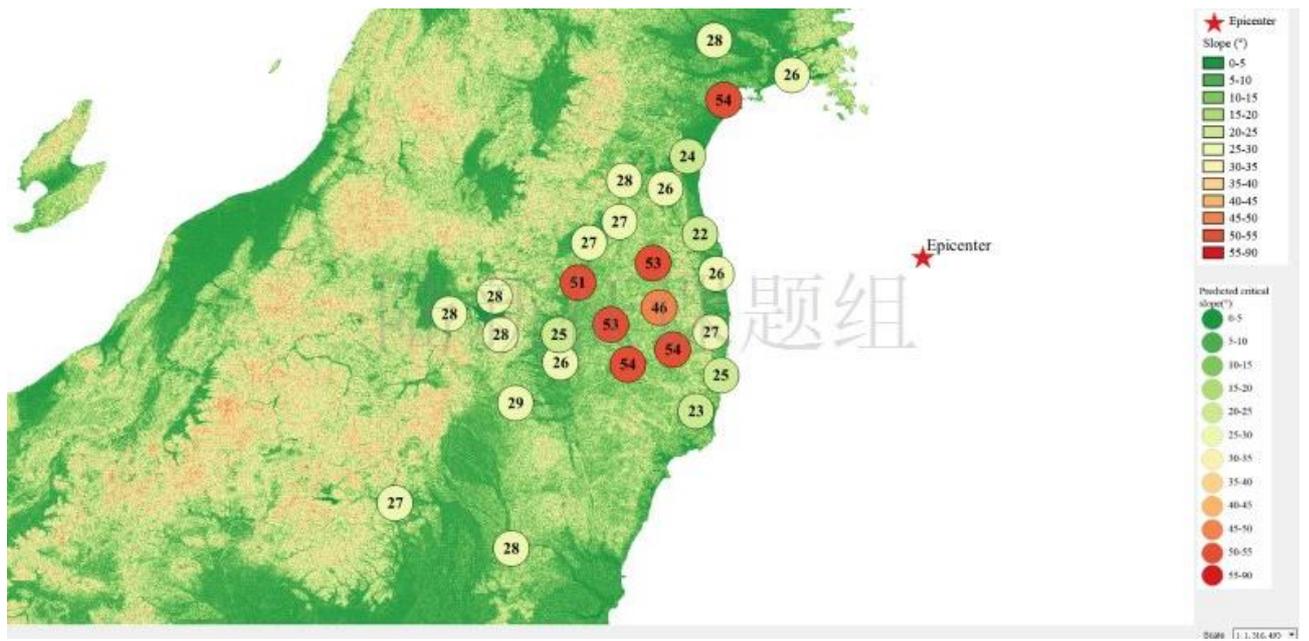
(c) The proportion of the landslide slab thickness that is saturated equals 90%  
 Figure 4 Distribution of earthquake-induced landslide near to different stations
