## RED-ACT Report

### Real-time Earthquake Damage Assessment using City-scale Time-history analysis

#### July 05, M7.1 California Ridgecrest Earthquake (V3)

Research group of Xinzheng Lu at Tsinghua University (luxz@tsinghua.edu.cn)

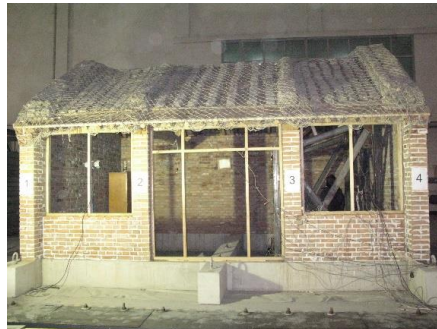
Figure 5 A single story unreinforced brick-wood residential building

**CICCC** records are input into a single story unreinforced masonry building in Figure 5. The damage state of the structure is **severe damage**. (Ji X D, et al. Shaking table test of unretrofitted and retrofitted brick-wood structures representative of existing rural buildings in Beijing. Journal of Building Structures, 2012, 11, 53-61.)
