RED-ACT Report

Real-time Earthquake Damage Assessment using City-scale Time-history analysis

Oct. 30, M6.9 Zozekanissos, Greece Earthquake

Research group of Xinzheng Lu at Tsinghua University (luxz@tsinghua.edu.cn)

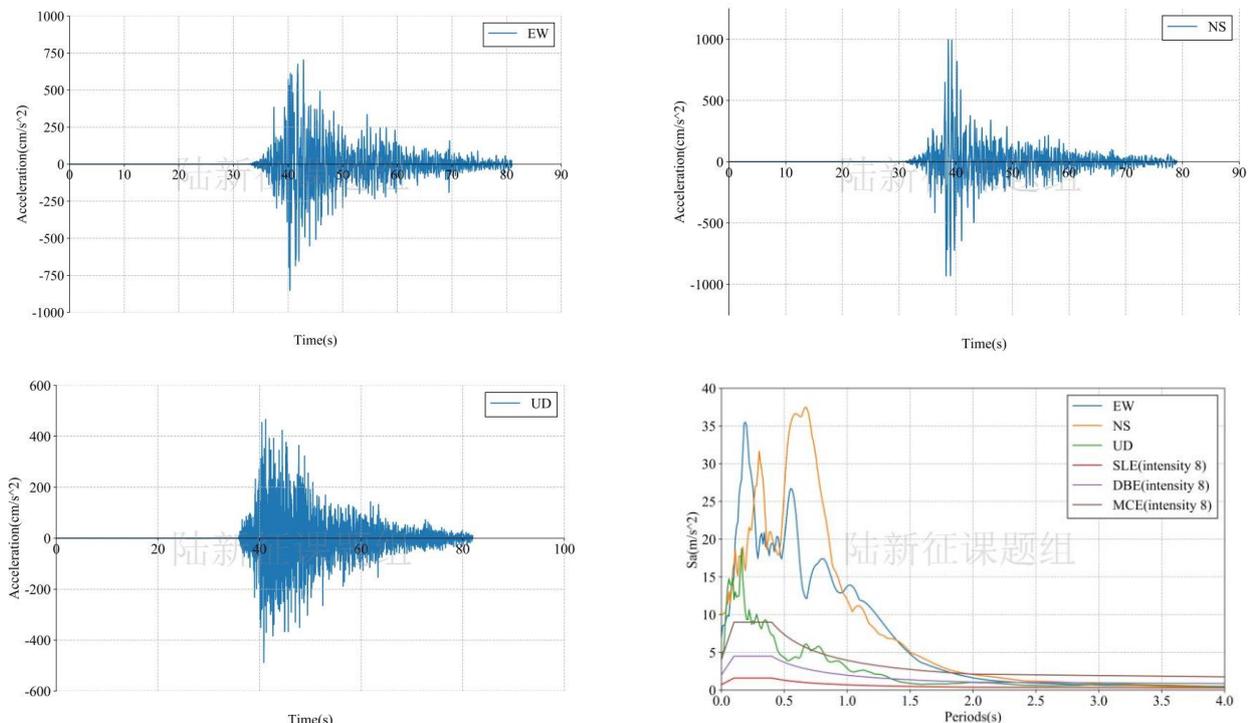
Figure 1 Waveform and response spectra of the recorded ground motions with maximal PGA

1 ground motions near to epicenter of this earthquake were analyzed. The names and locations of the stations can be found Table 1. The maximal recorded peak ground acceleration (PGA) is **979.1** cm/s/s. The waveform and corresponding response spectra in comparison with the design spectra specified in the Chinese Code for Seismic Design of Buildings are shown in Figure 1.

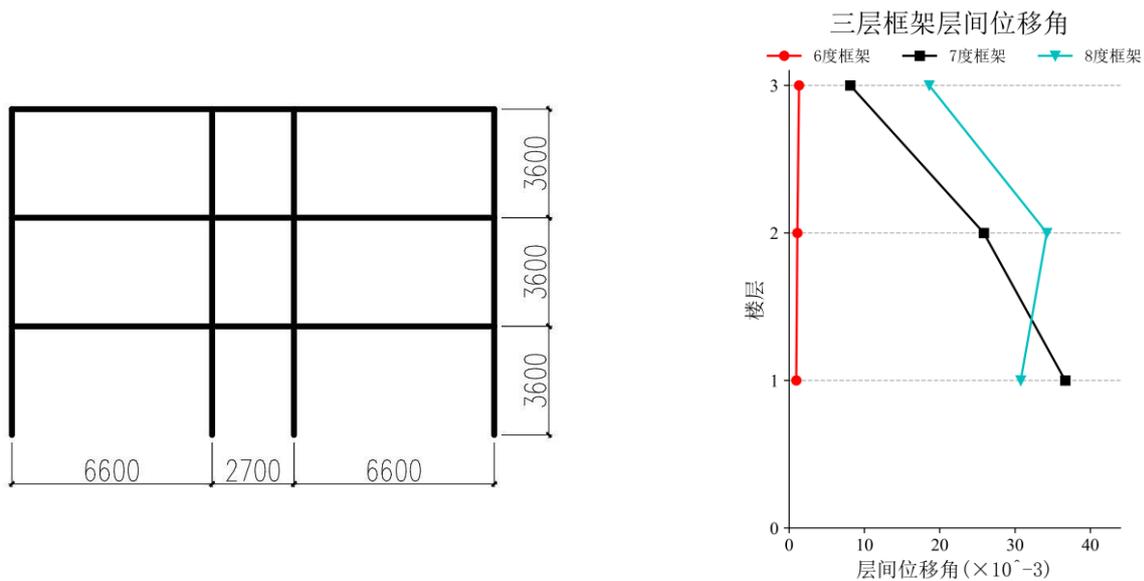
(a) Elevation view (unit: mm)

(b) Envelope of the inter-story drift ratios
(6-degree design building collapsed)

Figure 2 Three typical 3-story RC frames

The typical records are input into three typical 3-story reinforced concrete (RC) frames (Figure 2(a)), with seismic design intensities of 6-, 7-, and 8-degrees, respectively. The envelope of the inter-story drift ratios obtained from the nonlinear time-history analyses are shown in Figure 2(b).

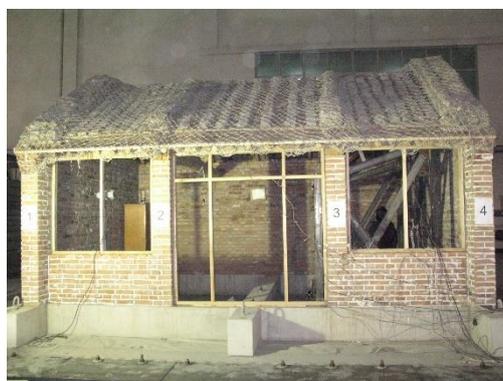
Figure 3 The shaking table test of a 1-story unreinforced brick-wood residential structure with three rooms

The typical records are input into a single story unreinforced masonry in Figure 3. The damage state of the structure is **Collapse**. (Ji X D, et al. Shaking table test of unreinforced and retrofitted brick-wood structures representative of existing rural buildings in Beijing. 2012, 11, 53-61.)

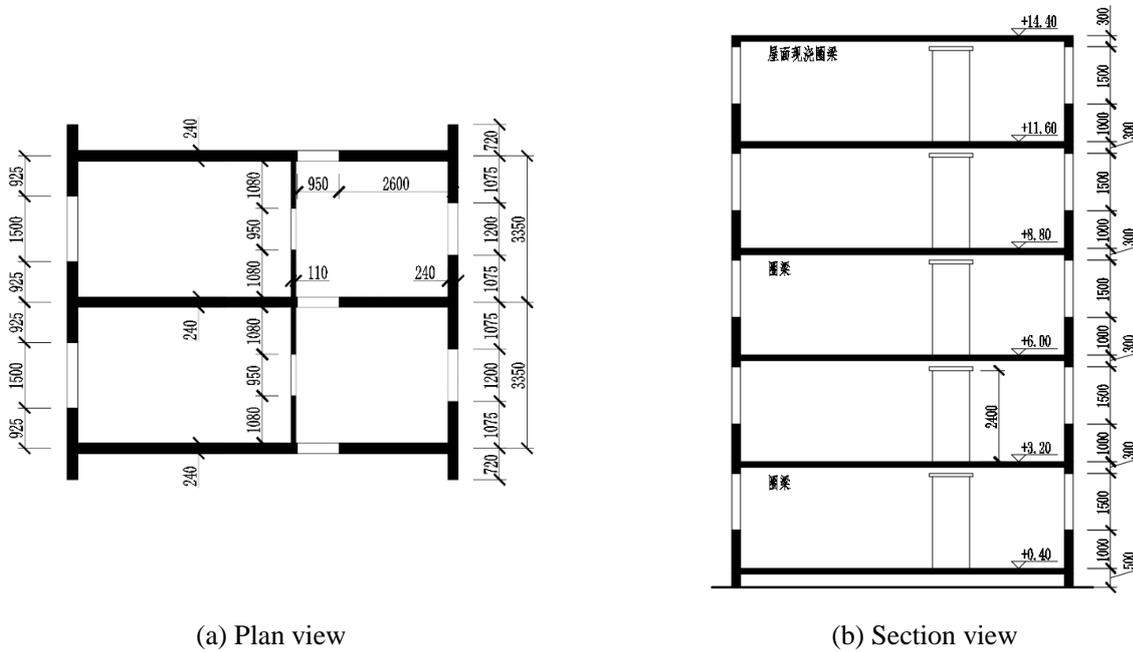
Figure 4 A 5-story simple masonry

The typical records are input into a 5-story simple masonry in Figure 4. The damage state of the structure is **Extensive damage**. (Zhu B L, et al. Seismic resistance capacity analysis of a five-story masonry test building in Shanghai)

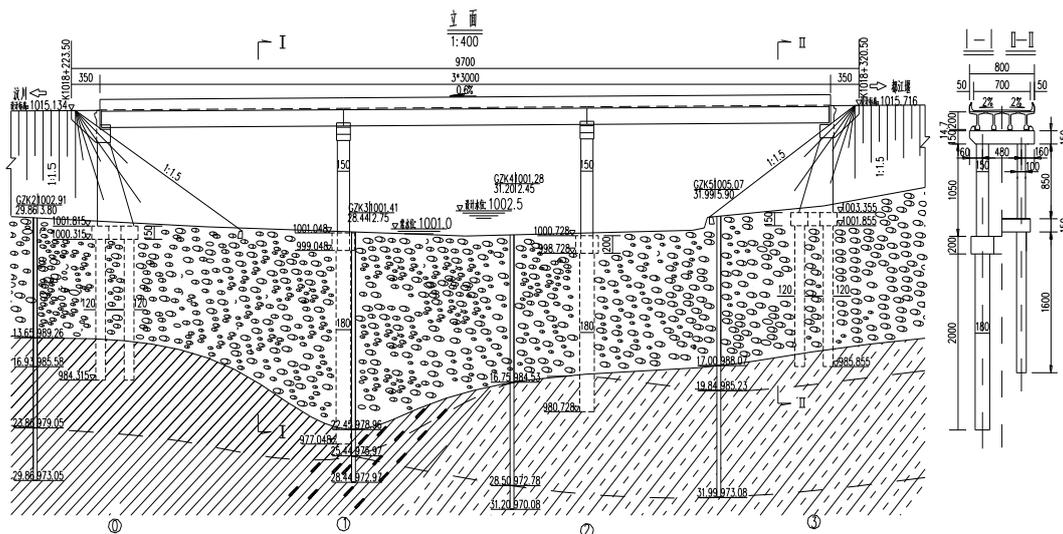
Figure 5 A highway bridge built in 1980s

Typical records are input into a highway bridge built in 1980s in Figure 5. The damage state of the bridge is **Extensive damage**.

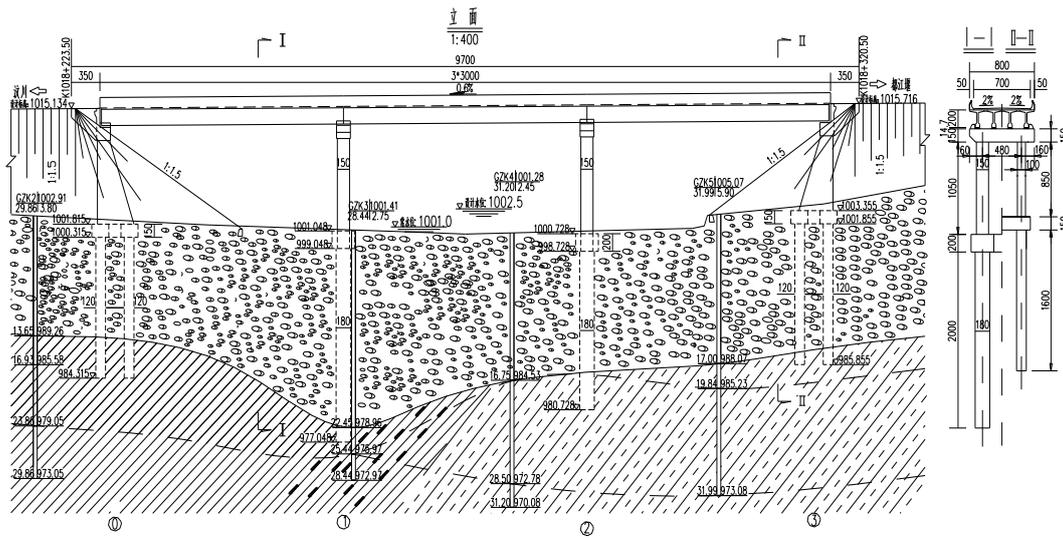
Figure 6 The approach bridge of a super large bridge

The typical records are input into the approach bridge of a super large bridge in Figure 6. The damage state of

the bridge is **Extensive damage**.
