RED-ACT Report

Real-time Earthquake Damage Assessment using City-scale Time-history analysis

Apr. 11, M6.0 Japan Sanriku Oki Earthquake

Research group of Xinzheng Lu at Tsinghua University (luxz@tsinghua.edu.cn)

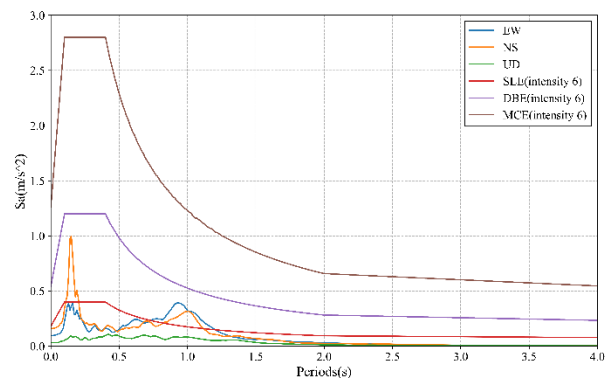
Figure 1 Response spectra of the recorded ground motions with maximal PGA

10 ground motions near to epicenter of this earthquake were analyzed. The names and locations of the stations can be found Table 1. The maximal recorded peak ground acceleration (PGA) is **16 cm/s/s**. The corresponding response spectra in comparison with the design spectra specified in the Chinese Code for Seismic Design of Buildings are shown in Figure 1.

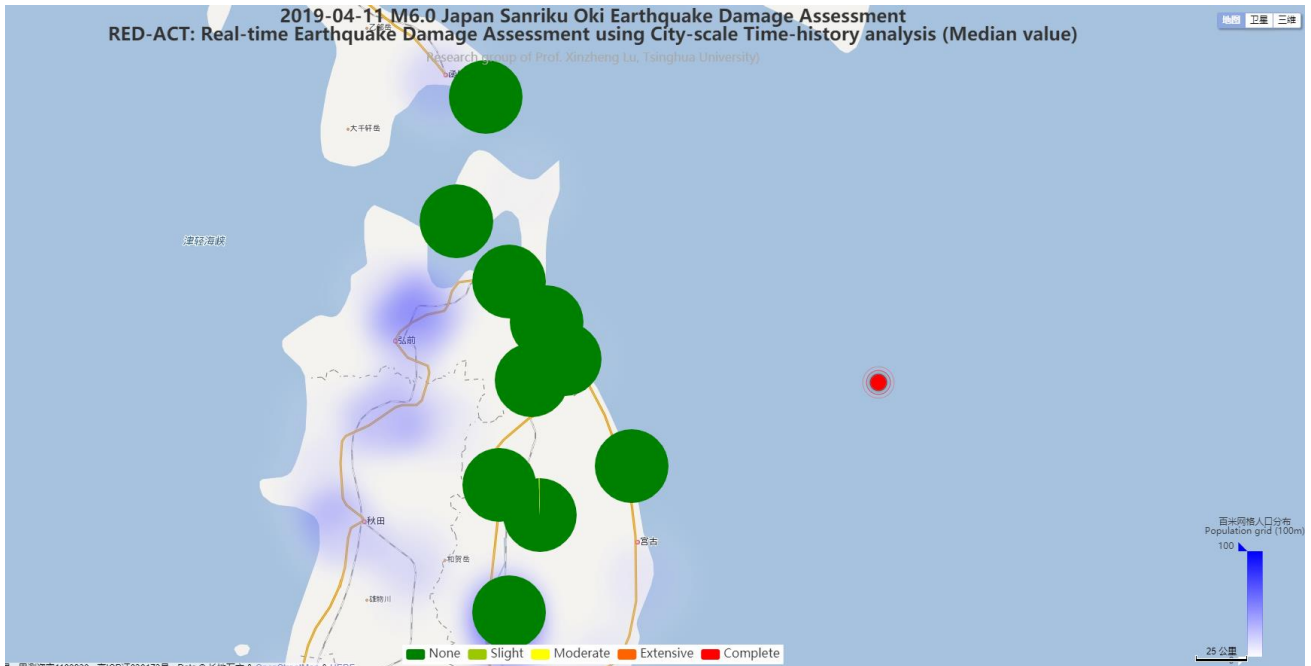
Figure 2 Damage ratio distribution of the buildings near to different stations

Using the real-time ground motions obtained from the strong motion networks and the **city-scale nonlinear time-history analysis (see the Appendix of this report)**, the damage ratios of buildings located in different places can be obtained. The building damage distribution and the human uncomfotableness distribution near to different stations is shown in Figure 2 and Figure 3, respectively. These outcomes can provide a reference for post-earthquake rescue work.

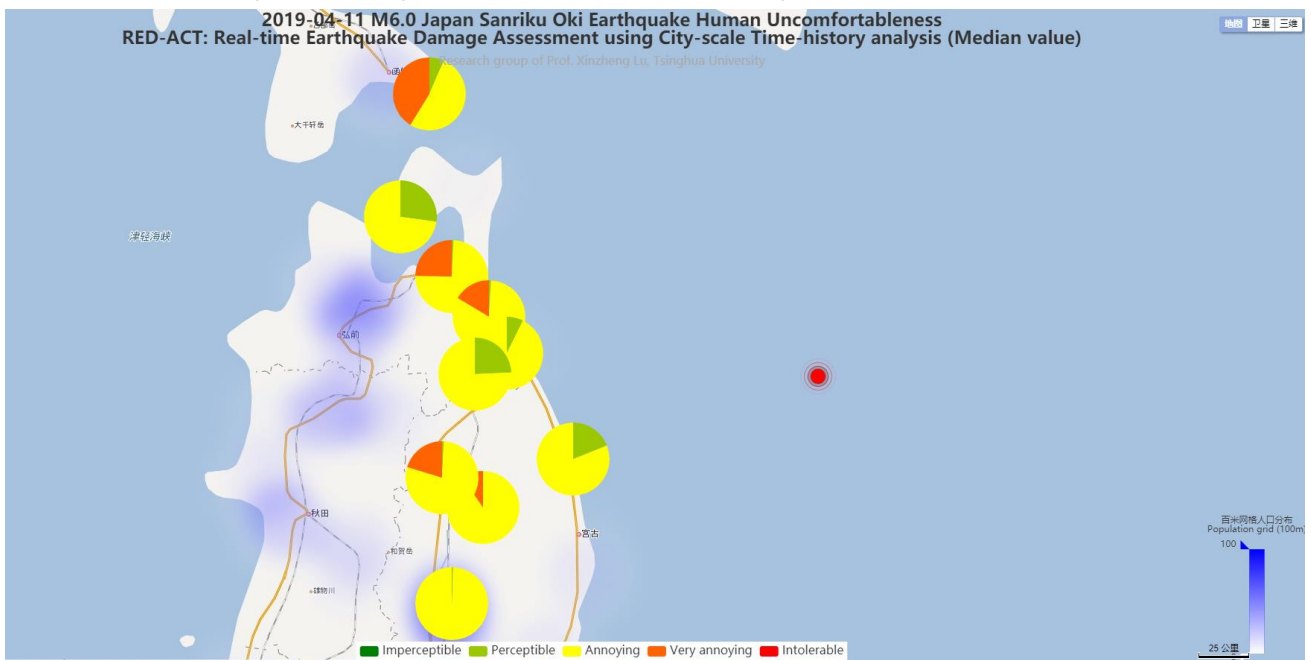
Figure 3 Human uncomfortableness distribution near to different stations

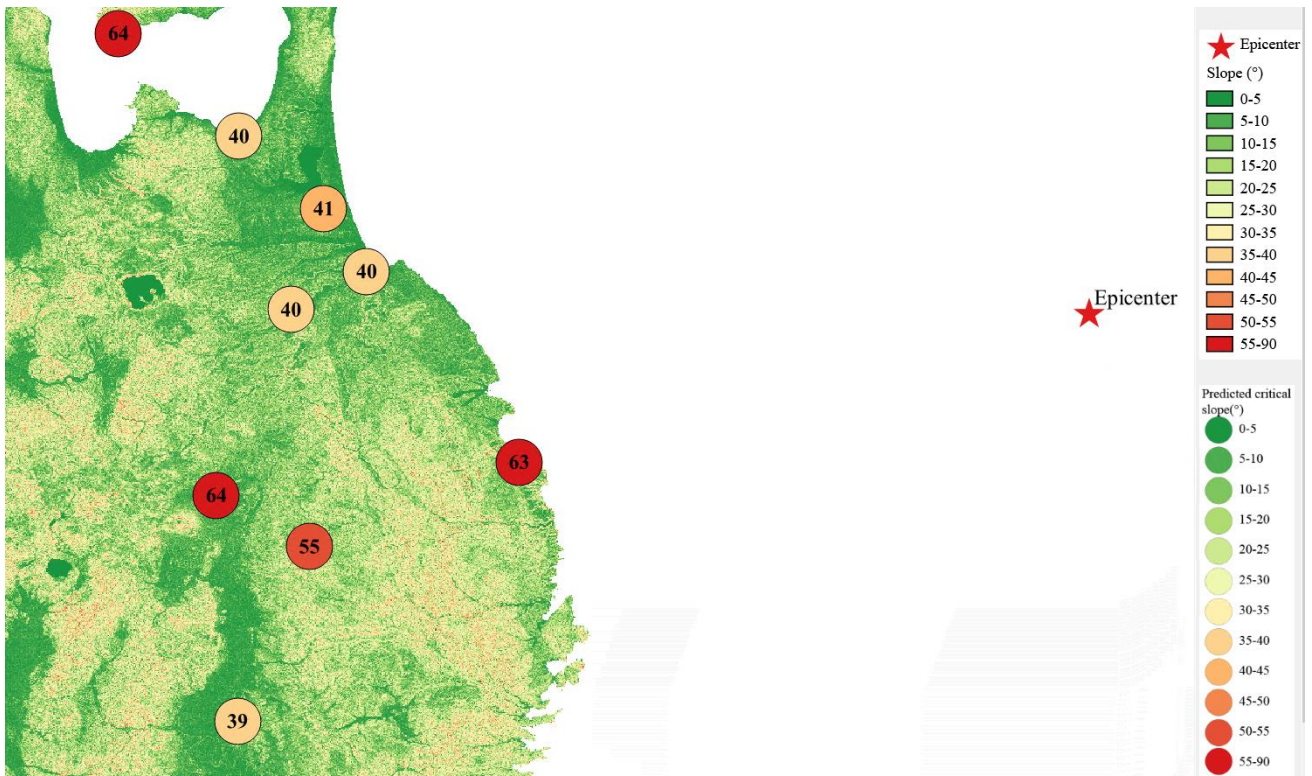
(a) The proportion of the landslide slab thickness that is saturated equals 0%

According to local topographic data, lithology data and ground motion records, the distribution of earthquake-induced landslide near to different stations under the different proportions of the landslide slab thickness that is saturated can be calculated, as shown in Figure 4. The basemap shows the distribution of the local slope. The number in the circle represents the critical slope of the landslide. The earthquake-induced landslide tends to occur with a higher probability when the slope is larger than this threshold value.

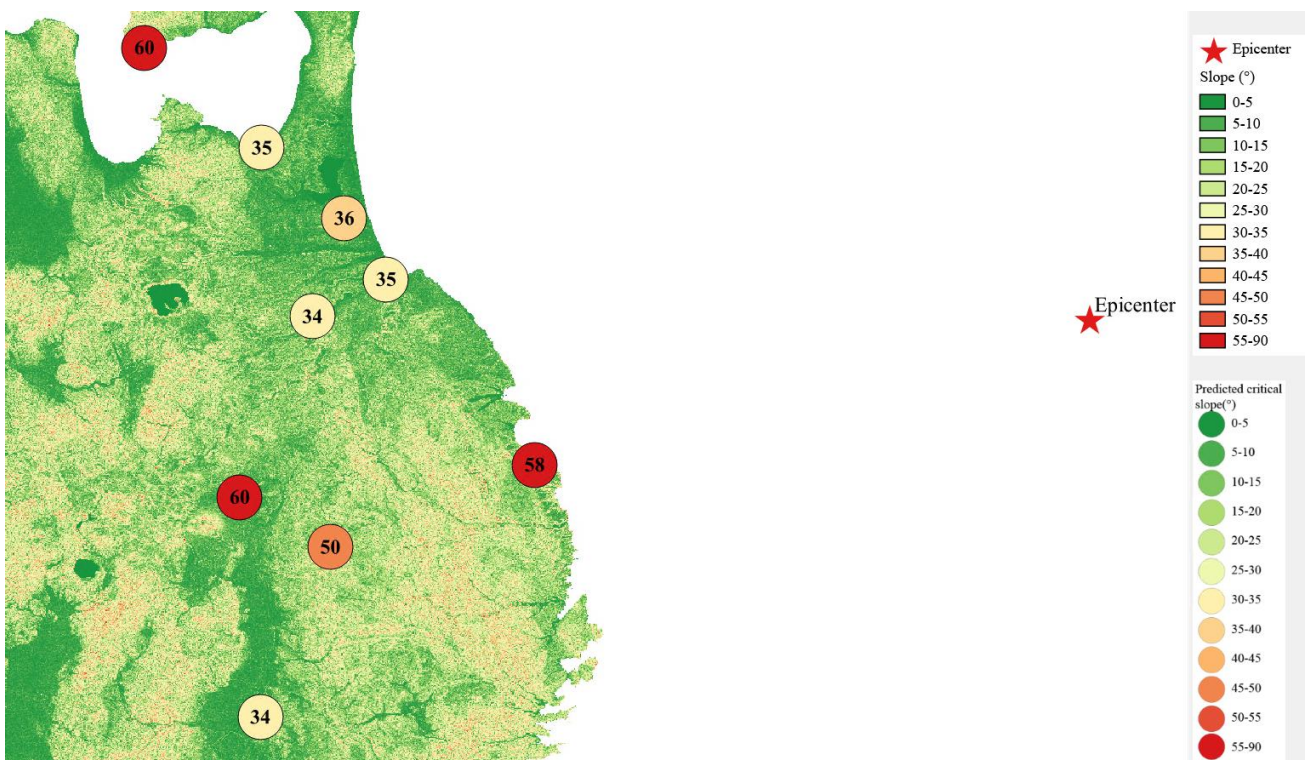
(b) The proportion of the landslide slab thickness that is saturated equals 50%

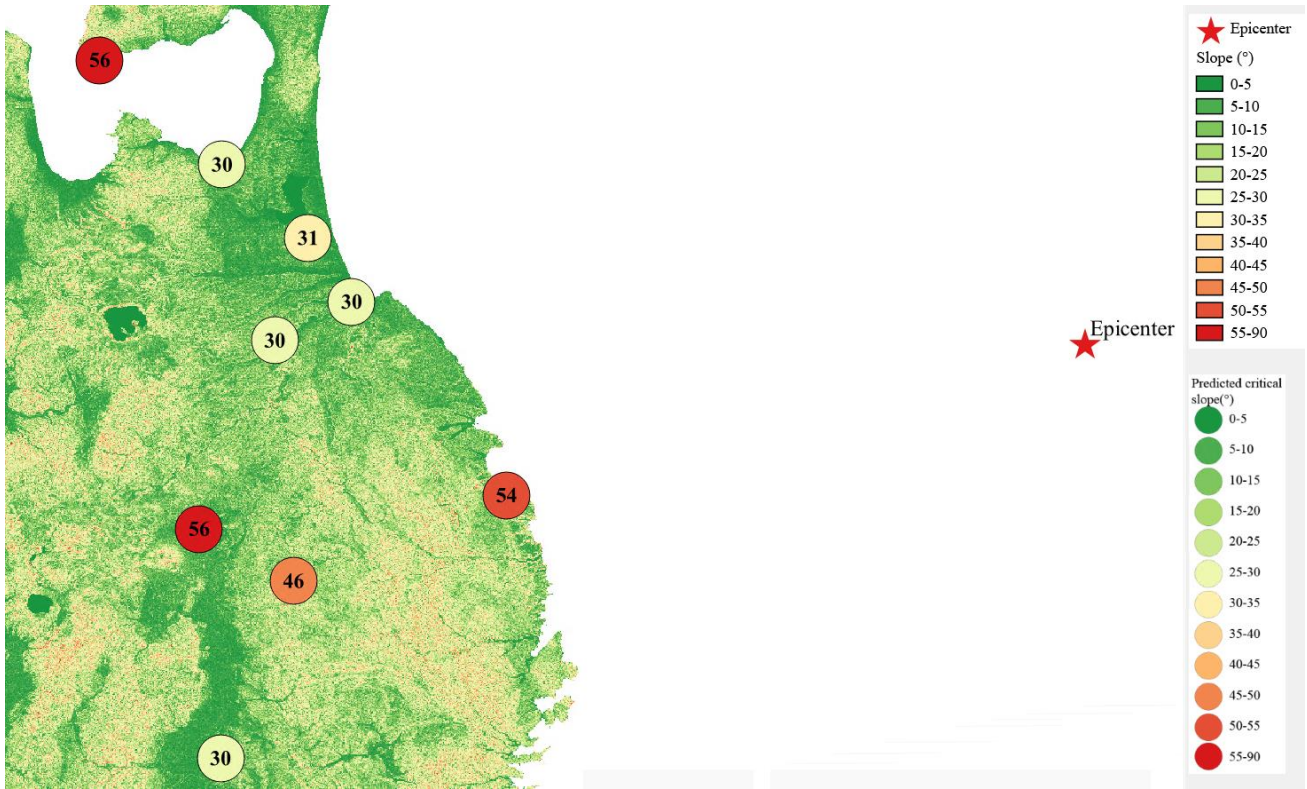
(c) The proportion of the landslide slab thickness that is saturated equals 90%
 Figure 4 Distribution of earthquake-induced landslide near to different stations
