## RED-ACT Report

### Real-time Earthquake Damage Assessment using City-scale Time-history analysis

#### May. 5, M5.3 Japan Nemuro-hanto Nanto-oki Earthquake

Research group of Xinzheng Lu at Tsinghua University (luxz@tsinghua.edu.cn)

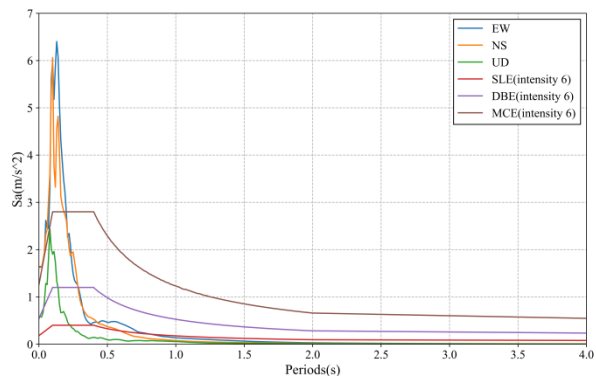
Figure 1 Response spectra of the recorded ground motions with maximal PGA

**10** ground motions near to epicenter of this earthquake were analyzed. The names and locations of the stations can be found Table 1. The maximal recorded peak ground acceleration (PGA) is **164 cm/s/s**. The corresponding response spectra in comparison with the design spectra specified in the Chinese Code for Seismic Design of Buildings are shown in Figure 1.

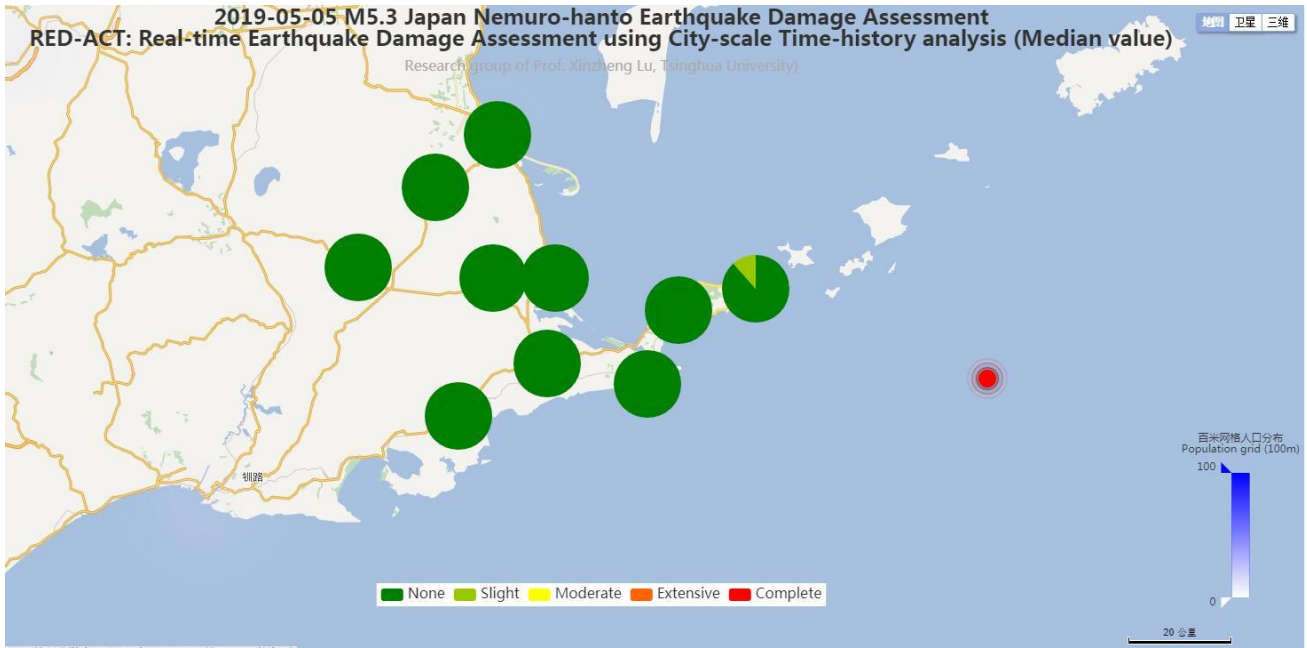
Figure 2 Damage ratio distribution of the buildings near to different stations

Using the real-time ground motions obtained from the strong motion networks and the **city-scale nonlinear time-history analysis (see the Appendix of this report)**, the damage ratios of buildings located in different places can be obtained. The building damage distribution and the human uncomfotableness distribution near to different stations is shown in Figure 2 and Figure 3, respectively. These outcomes can provide a reference for post-earthquake rescue work.

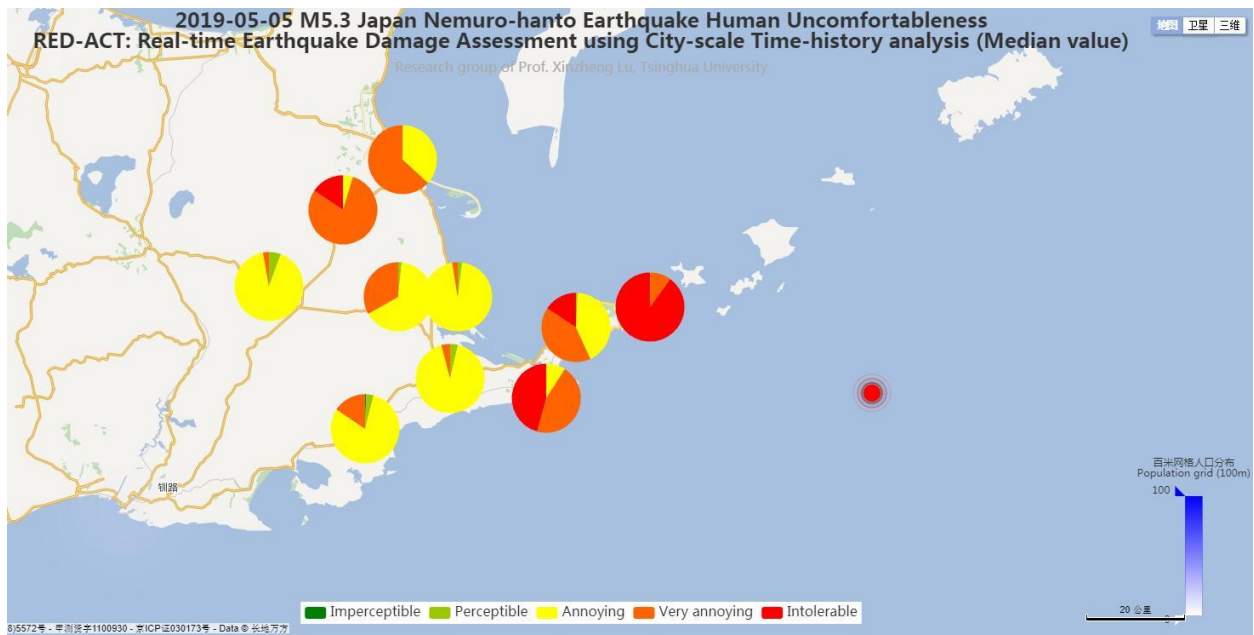
Figure 3 Human uncomfortableness distribution near to different stations

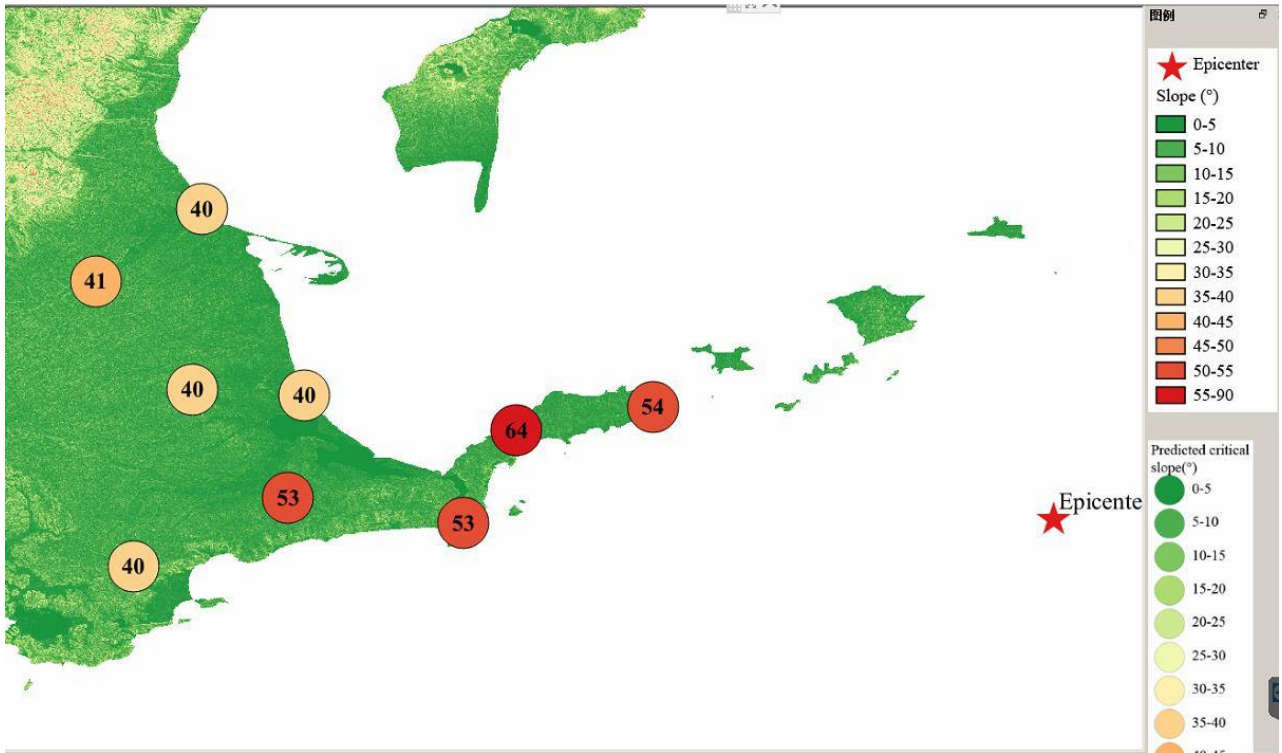
(a) The proportion of the landslide slab thickness that is saturated equals 0%

According to local topographic data, lithology data and ground motion records, the distribution of earthquake-induced landslide near to different stations under the different proportions of the landslide slab thickness that is saturated can be calculated, as shown in Figure 4. The basemap shows the distribution of the local slope. The number in the circle represents the critical slope of the landslide. The earthquake-induced landslide tends to occur with a higher probability when the slope is larger than this threshold value.

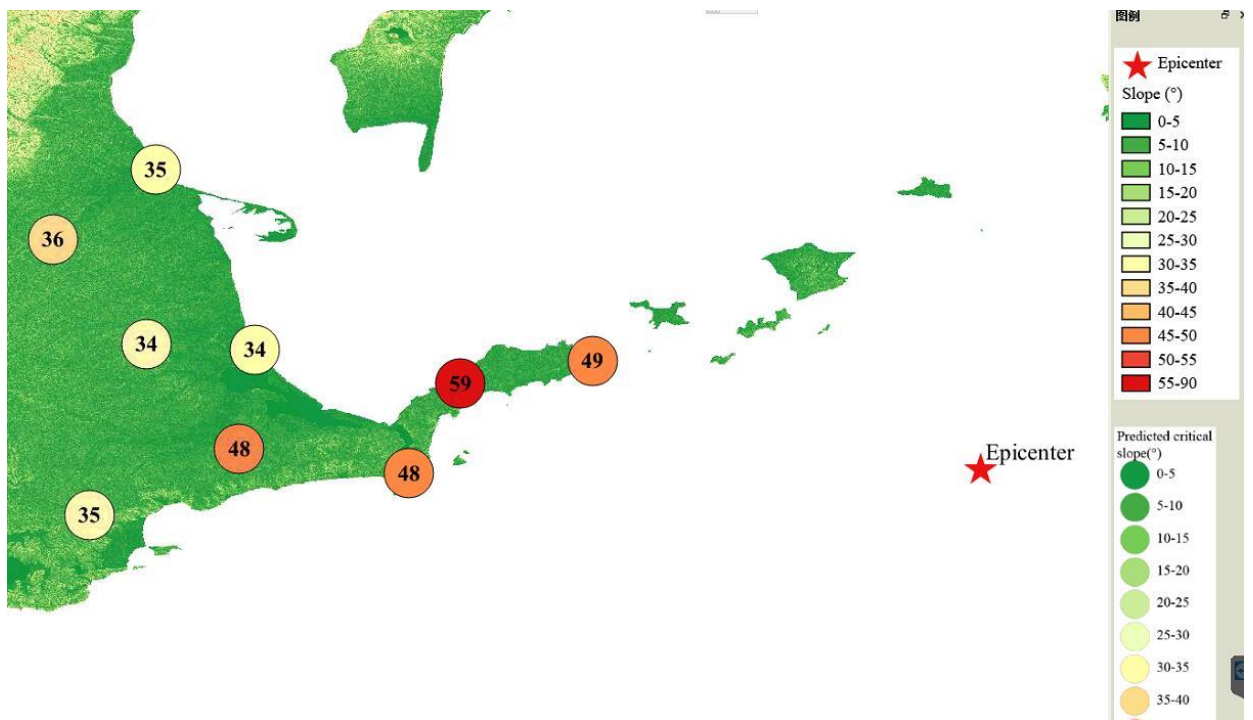
(b) The proportion of the landslide slab thickness that is saturated equals 50%

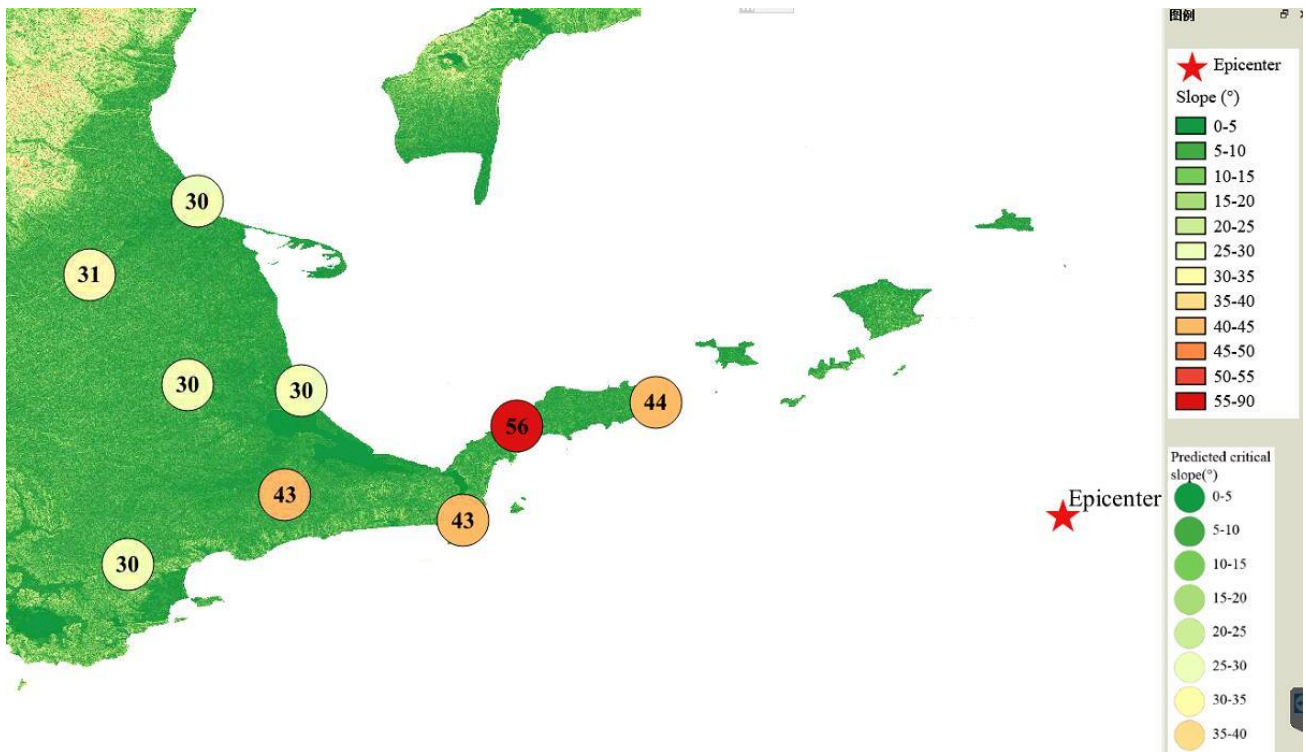
(c) The proportion of the landslide slab thickness that is saturated equals 90%  
 Figure 4 Distribution of earthquake-induced landslide near to different stations
